Last updated: 28 October 2018
Status: Final
Date: Sunday 5 July 2009
Time: 13:05

Type: [Britten-Norman BN-2A Trislander Mk.III-1](#)
Operator: [Great Barrier Airlines \(New Zealand\)](#)
Registration: ZK-LOU
C/n / msn: 322
First flight: 1972-11-01 (36 years 9 months)
Engines: 3 [Lycoming O-540-E4C5](#)
Crew: Fatalities: 0 / Occupants: 1
Passengers: Fatalities: 0 / Occupants: 10
Total: Fatalities: 0 / Occupants: 11
Aircraft damage: Substantial
Aircraft fate: Written off (damaged beyond repair)
Location: near Great Barrier Island Airport (GBZ) (  [New Zealand](#))
Phase: Initial climb (ICL)
Nature: Domestic Scheduled Passenger
Departure airport: [Great Barrier Island Airport \(GBZ/NZGB\)](#), New Zealand
Destination airport: [Auckland International Airport \(AKL/NZAA\)](#), New Zealand

A Britten-Norman BN-2A Trislander Mk.III-1 passenger plane sustained substantial damage in an accident near Great Barrier Island Airport (GBZ), New Zealand. There were ten passengers and one pilot on board. Three passengers suffered minor injuries.

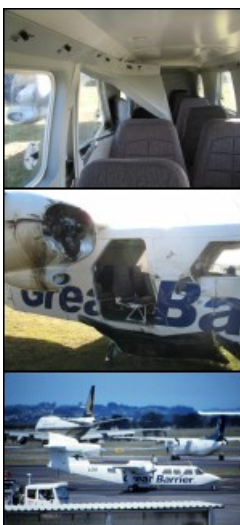
1. The engine propeller assembly separated from the right engine of ZK-LOU in flight and struck the fuselage when the

crankshaft failed at the flange that connected it to the propeller hub.

2. High-cycle fatigue cracking on the flange that had developed during normal operations from undetected corrosion had reached a critical stage and allowed the flange to fail in overload.

On 15 December 2009 the CAA issued Continuing Airworthiness Notice 85-005 advising operators and maintainers of the potential for cracking of Lycoming engines fitted with crankshaft propeller flanges with lightening holes because of corrosion, and the need to inspect periodically the flanges for corrosion damage.
