ATSB TRANSPORT SAFETY REPORT
Aviation Occurrence Investigation
AO-2008-070
Final

In-flight upset
154 km west of Learmonth, WA
7 October 2008
VH-QPA
Airbus A330-303

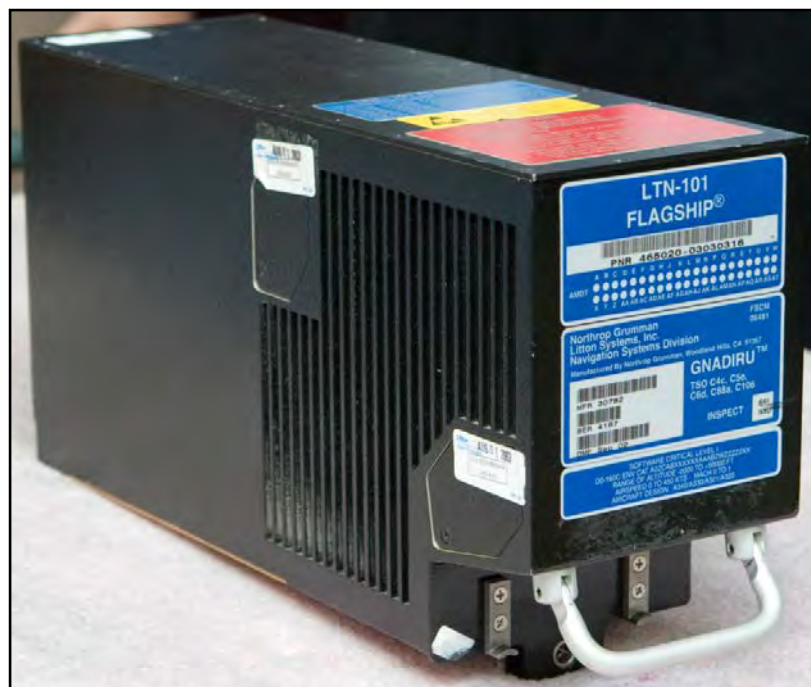
Figure 7: ADIRU 1 (ADIRU 4167) from QPA

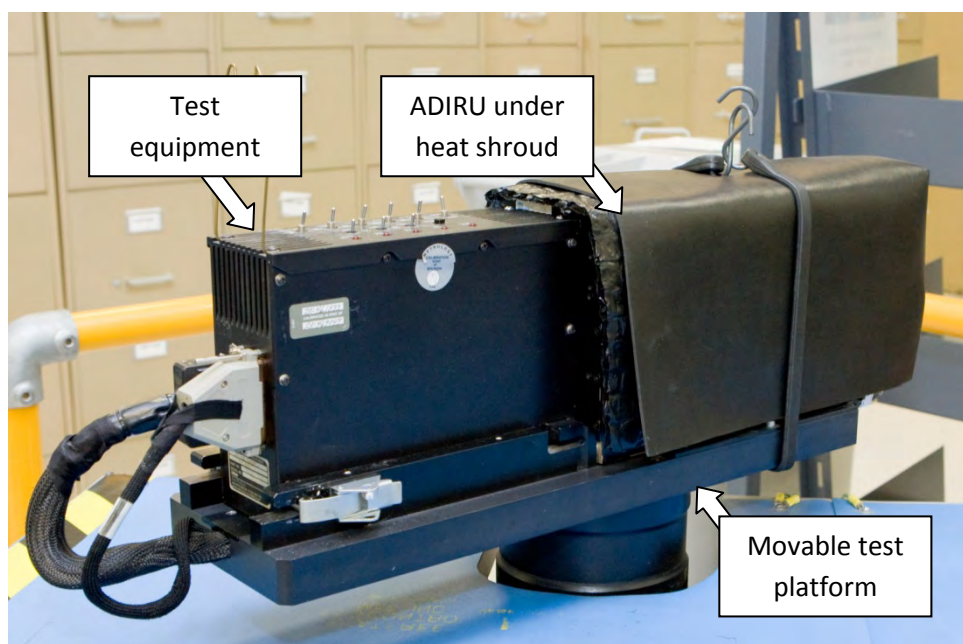
Figure E2: ADIRU undergoing test under heat shroud

Unit 4167 passed 2,223 of 2,272 tests, with the remainder failing due to navigation drift that was considered normal in a high-temperature environment. This issue was not considered relevant to the occurrences under investigation. No other problems were identified.
