ATSB TRANSPORT SAFETY REPORT
Aviation Occurrence Investigation
AO-2008-070
Final

In-flight upset
154 km west of Learmonth, WA
7 October 2008
VH-QPA
Airbus A330-303

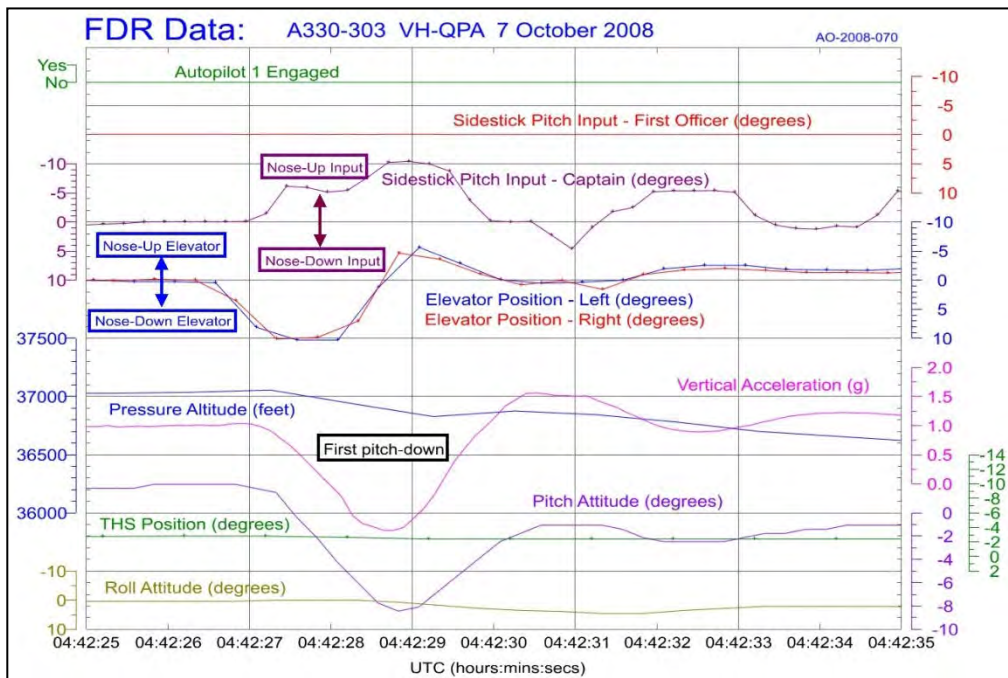
Figure 24: Acceleration, elevator and sidestick inputs for the first pitch-down

During both pitch-downs, both elevators' positions changed abruptly in the nose-down direction (Figure 24 and Figure 25). The magnitude of the change for the first pitch-down was larger, and the rate of change was approximately 15° per second. The duration of the second pitch-down was slightly longer than the first. The abrupt changes for both pitch-downs were followed soon after by a slower recovery period back to normal values.

The movements of the left and right elevators were consistent, and the magnitude of the elevator movements was also consistent with the magnitude of the aircraft's pitch changes.

There was no sidestick input that correlated with the initiation of either pitch-down. In both cases, very soon after the pitch-down commenced, the captain applied back pressure to the sidestick to produce a nose-up input. Each was moderate and commensurate with the response required to correct for the pitch-downs. The inputs did not have any immediate effect on the recorded elevator position, but within 1 to 2 seconds the elevator position started to correlate with the sidestick inputs. Figure 24 and Figure 25 show the sidestick pitch input parameters for the 10-second period around each pitch-down.

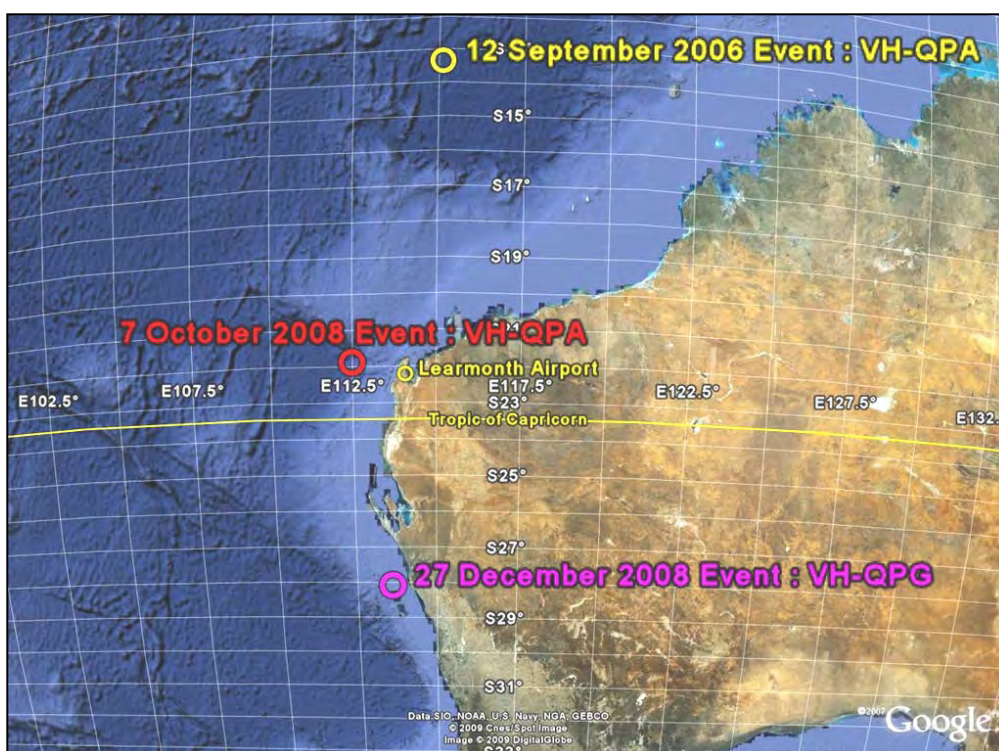
Figure 26: Locations of the three ADIRU data-spike occurrences⁷²

The three occurrences all happened off the coast of Western Australia (Figure 26), although there were significant distances between the three events. Summary details of the three occurrences are provided in Table 18.

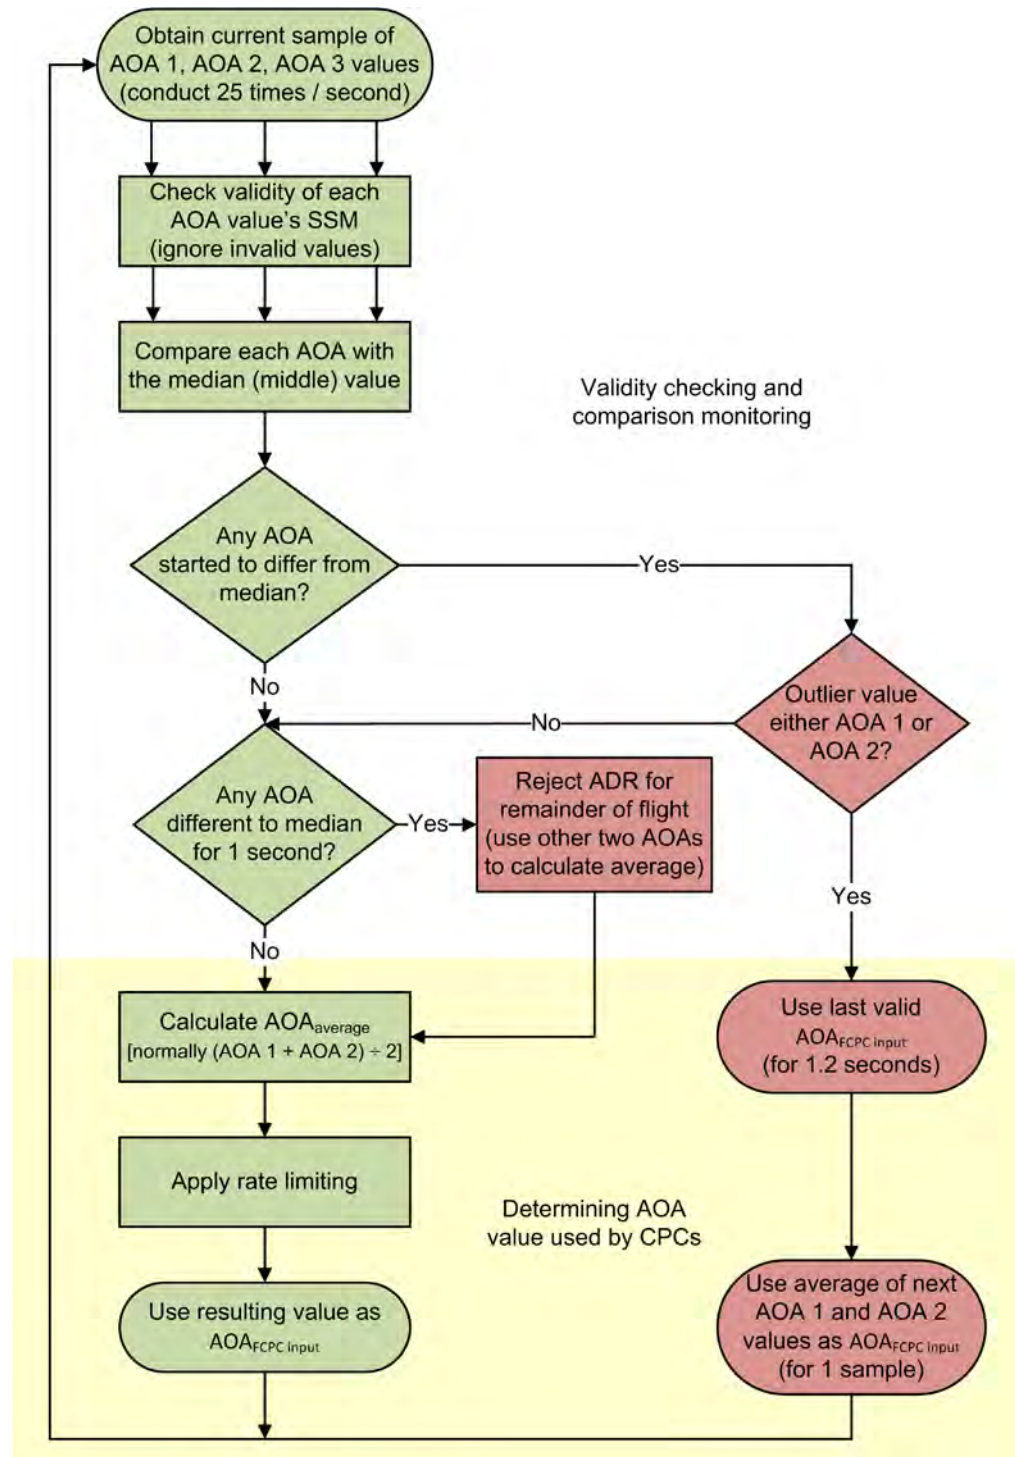
Figure 28: FCPC algorithm for processing AOA data⁷⁸

The basic process used by the FCPCs for checking the validity and consistency of the AOA data is shown in the upper portion of Figure 28. The FCPCs monitored the three ADIRUs' output values every 40 msec (or 25 times per second). If any of the three values deviated from the median by more than a predetermined threshold for more than 1 second, then the FCPC rejected the relevant ADR for the remainder of the flight.

For most of the ADIRU parameters, the FCPC software used the median value when computing the control orders. The use of the median of three values as the system input was a common technique to ensure that significant discrepancies in one value would not influence system performance. Although the use of the median values as the input is generally a robust process, there are still many aspects that need to be considered to ensure that an algorithm works effectively (Butler 2006).

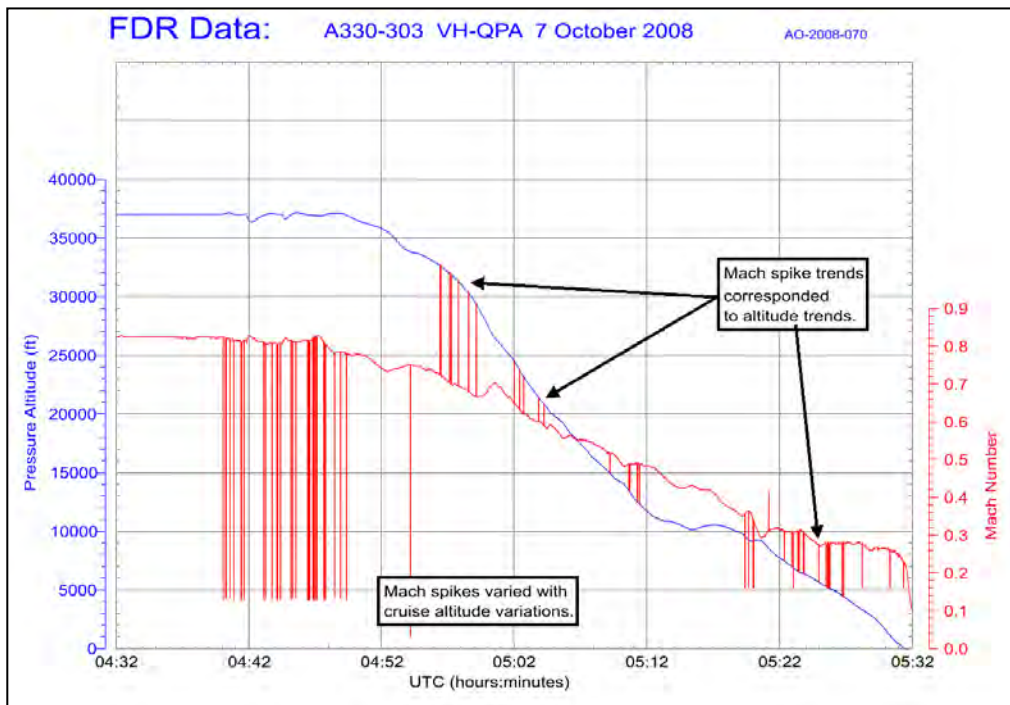
Figure 41: Qualitative correlation between Mach spikes and altitude

A review of the data-spike values for Mach indicated that many of them appeared to vary with altitude. A more detailed examination identified the following relationship (see also Figure 41 and Figure 42):

- While the aircraft was at 37,000 ft, the value of most of the Mach spikes was 0.128. The Mach binary values corresponded to the altitude binary values for 37,000 ft (see also Figure 39).¹³¹
- During the aircraft's descent to Learmonth, the binary values for most of the Mach spikes corresponded to the altitude value at the same time.
- Overall, 88% of the ARINC 429 binary values for the Mach spikes matched exactly with the corresponding altitude values at the corresponding time.

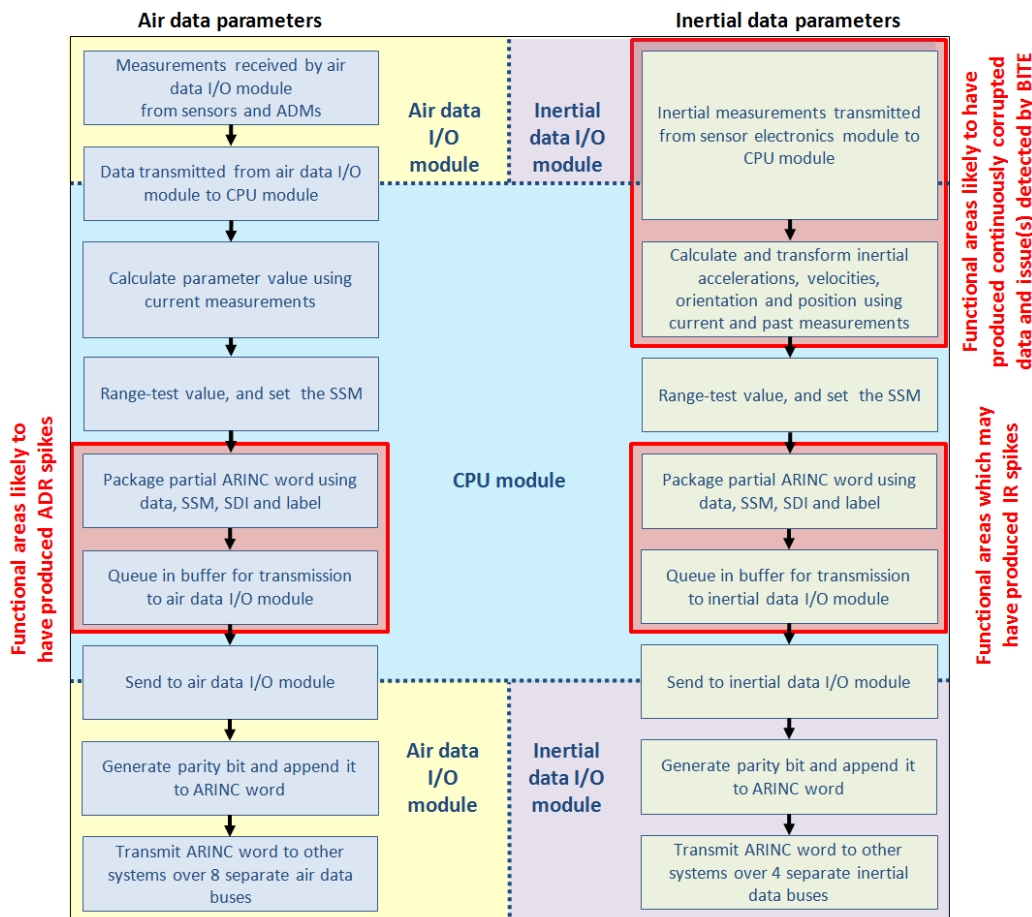
Figure 45: Summary of the data flow for the ADR and IR parameters

parameters is provided in Figure 45.¹³² The processing stages considered likely to be affected by the data-spike failure mode are highlighted in red in Figure 45 and discussed in the remainder of this section.

Based on the various analyses, the investigation was able to limit the possible functional areas that could have produced the observed output data patterns (as summarised in Figure 45). More specifically:

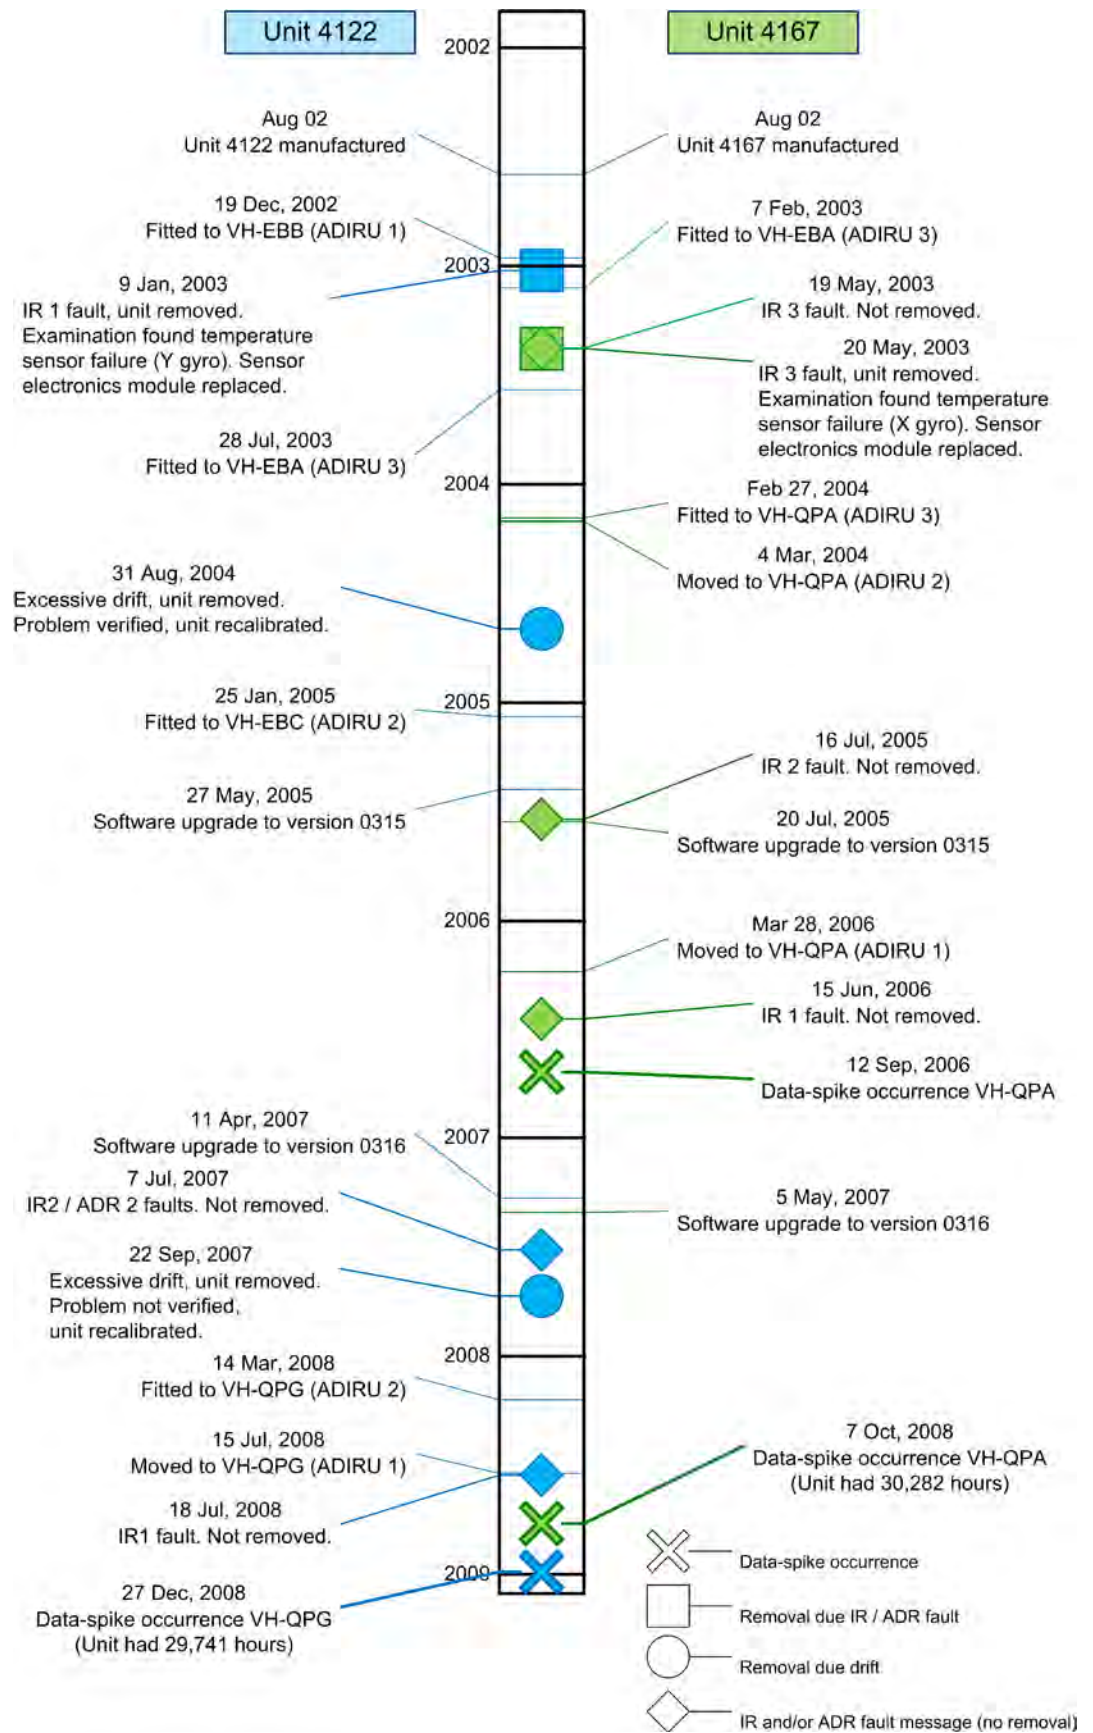
Figure 46: Service history timeline for units 4122 and 4167

Details of the service histories of units 4167 and 4122 are summarised in Figure 46. Notable features include:

The key hardware components in the CPU modules of units 4167 and 4122 were very similar, but the number of other units that had the same level of similarity could not be determined as component details were not recorded.

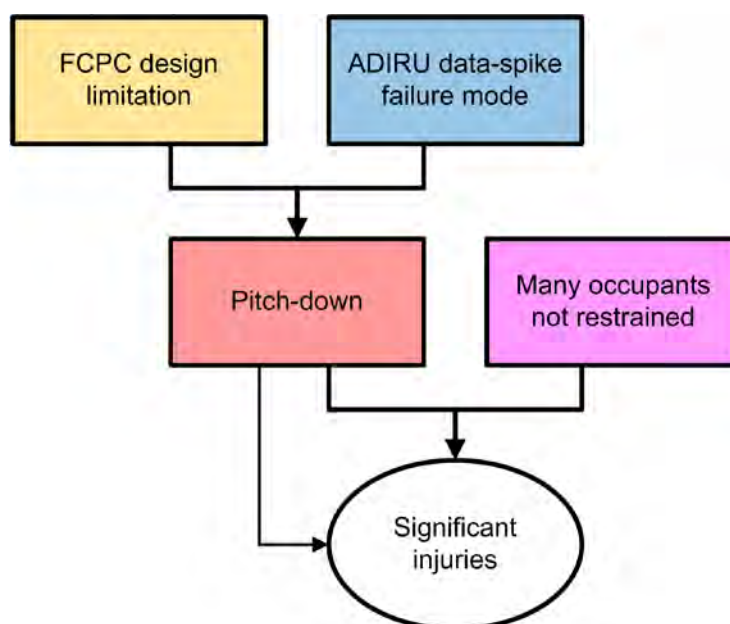
Figure 53: Overview of the 7 October 2008 occurrence

A summary of the main factors involved in the occurrence is presented in Figure 53. In essence, a design limitation with the FCPC software combined with an ADIRU failure to falsely activate the corrective mechanisms and produce the pitch-downs. The subsequent vertical accelerations led to a large number of injuries to the aircraft's occupants, with the number and extent of these injuries being exacerbated by many of the occupants not wearing seat belts.

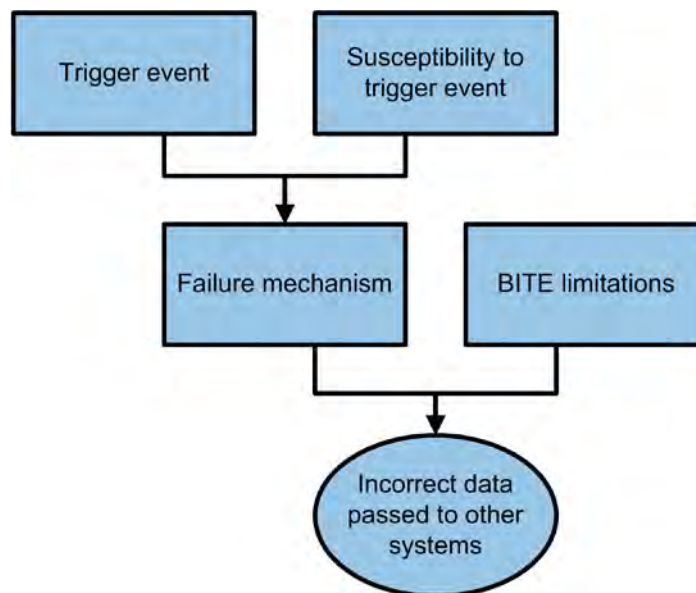
Figure 55: Simplified model of the ADIRU data-spike failure mode

The most significant aspect of the failure mode associated with the pitch-downs was that the ADR data spikes (particularly for AOA) were sent to the FCPCs and other systems as valid data. The elements involved in producing these data spikes are summarised in Figure 55. In simple terms, a trigger event combined with a susceptibility within the ADIRU to that type of trigger event to initiate a failure mechanism that disrupted the ADIRU's internal processing and generated the data spikes. A limitation in the coverage of the ADIRU's built-in test equipment (BITE) meant that the ADR data spikes were transmitted to other systems as valid data.

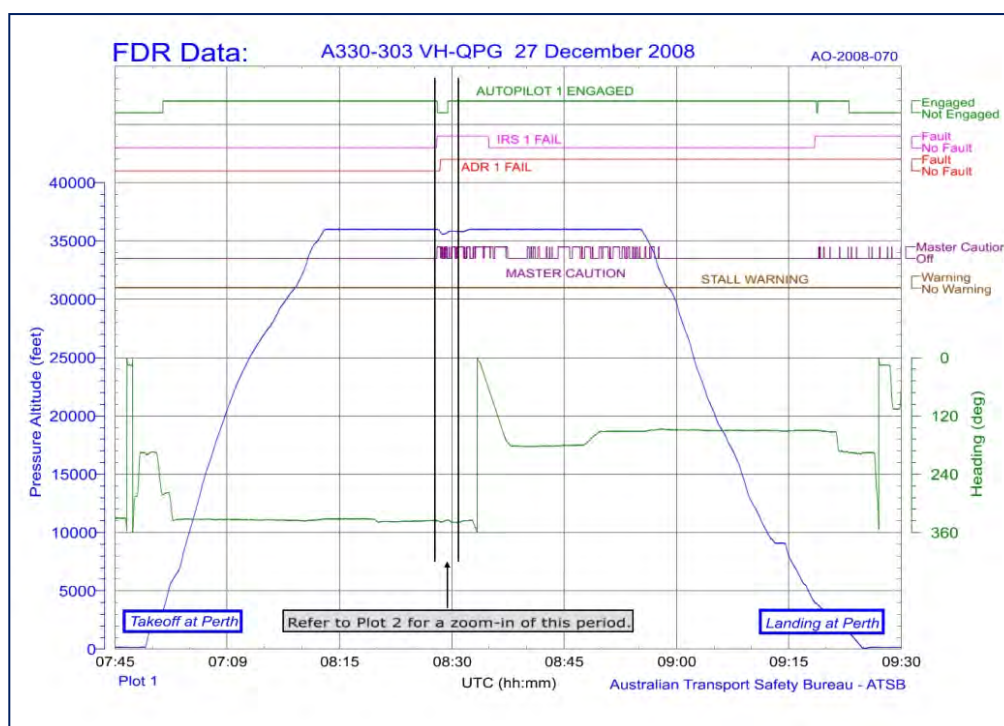
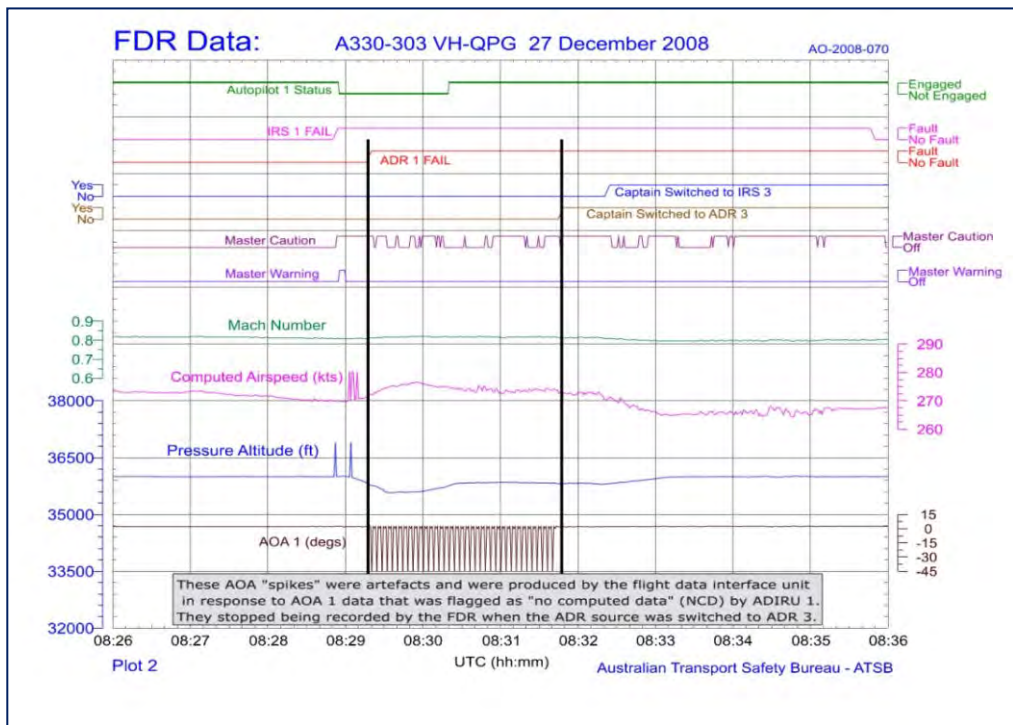
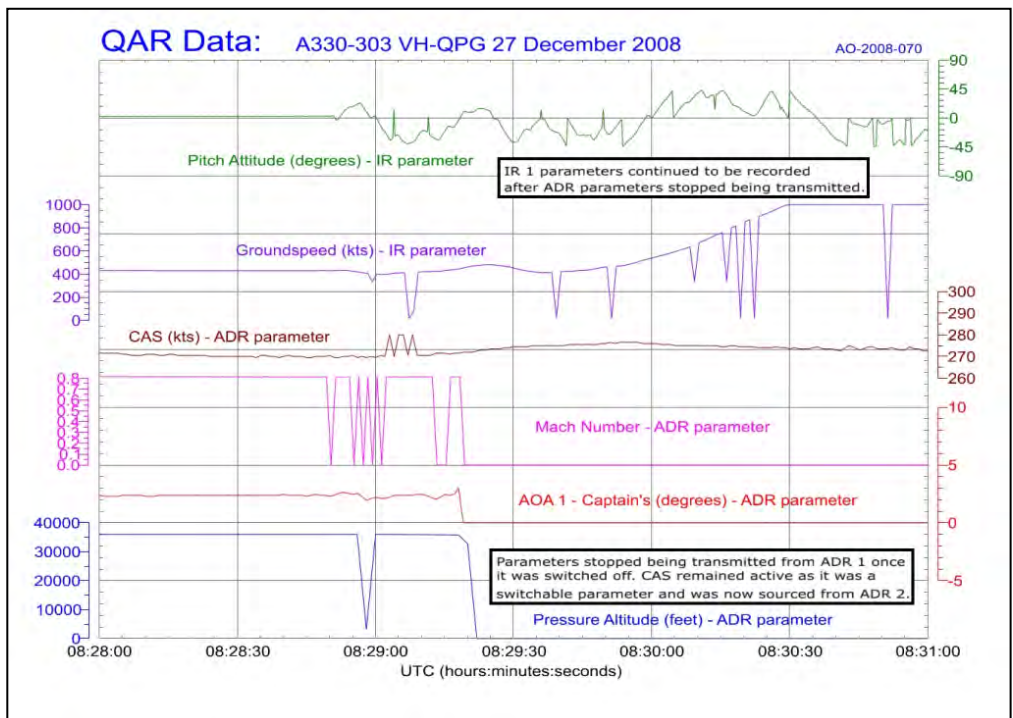
The recorded data showed that the failure mode started at 0828:52. In terms of the ADR data, the crew selected ADR 1 OFF 28 seconds after the failure mode started (at 0829:20). Consequently, ADR 1 ceased transmitting data and the FDR switched its source for the ADR parameters, except angle of attack (AOA) 1 and AOA 2, from ADR 1 to ADR 3.²⁰⁵ When the crew switched the source of ADR parameters for the captain's displays to ADR 3 (0831:25), the FDR's source of AOA 1 also switched to ADR 3. During the brief period that ADR 1 data was recorded:

- There were no spikes in AOA²⁰⁶ or Mach.
- There were two spikes for altitude, and two spikes for static air temperature. There were also four small changes (10 kts) in computed airspeed. ADIRU 1 flagged all of these anomalies as valid data.

There were no stall warnings recorded (consistent with no spikes on the captain's AOA) and no overspeed warnings recorded (consistent with only small changes on computed airspeed). However, there were repetitive master cautions recorded after the failure mode commenced, consistent with the occurrence of ECAM messages.

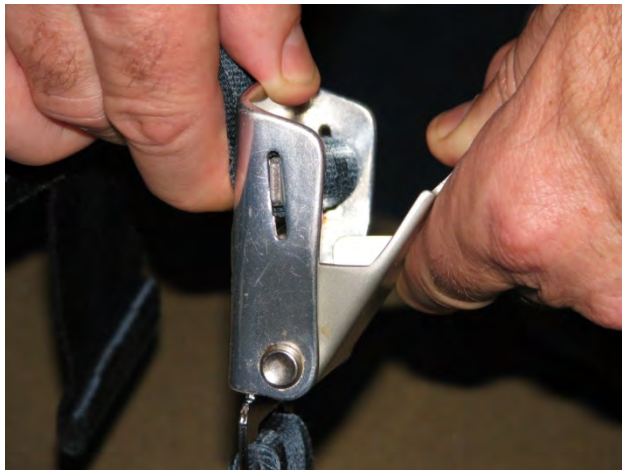
Figure J2: Seat-belt buckle on VH-QPA with buckle cover open

The buckle was on the passenger's left side and the connector on the right side, with the end fittings of both parts being attached to anchorage points on the aircraft seat. To fasten the seat belt, the connector was inserted into the buckle. To release the belt, the buckle cover (or flap) was lifted 30° or more (Figure J2).
